**ALLSTAR PZL GLIDER Sp. z o.o.**  
ul. Cieszyńska 325  
43-300 Bielsko-Biała  
phone: +48 (0)33 8125021, fax: +48 (0)33 8123739  
e-mail: office@szd.com.pl  
Approval No: EASA Nr AP 108

**SERVICE BULLETIN**  
**No BE-059/SZD-50-3/2007 „PUCHACZ”**

**DESIGNATION-TYPE/MODEL:** SZD-50-3 „Puchacz”

**CONCERNS:** Inspection of the intermediate lever bolt in airbrake  
control system in the wing.

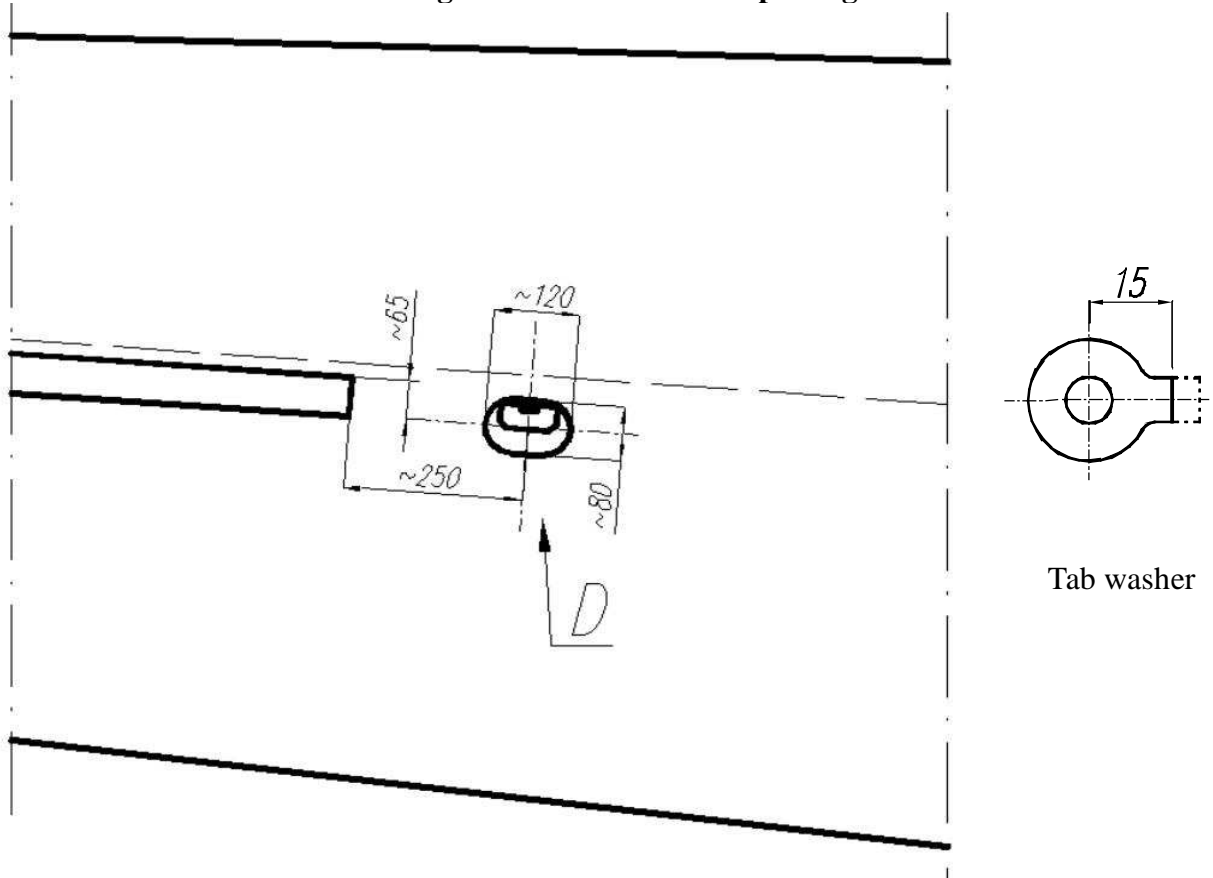
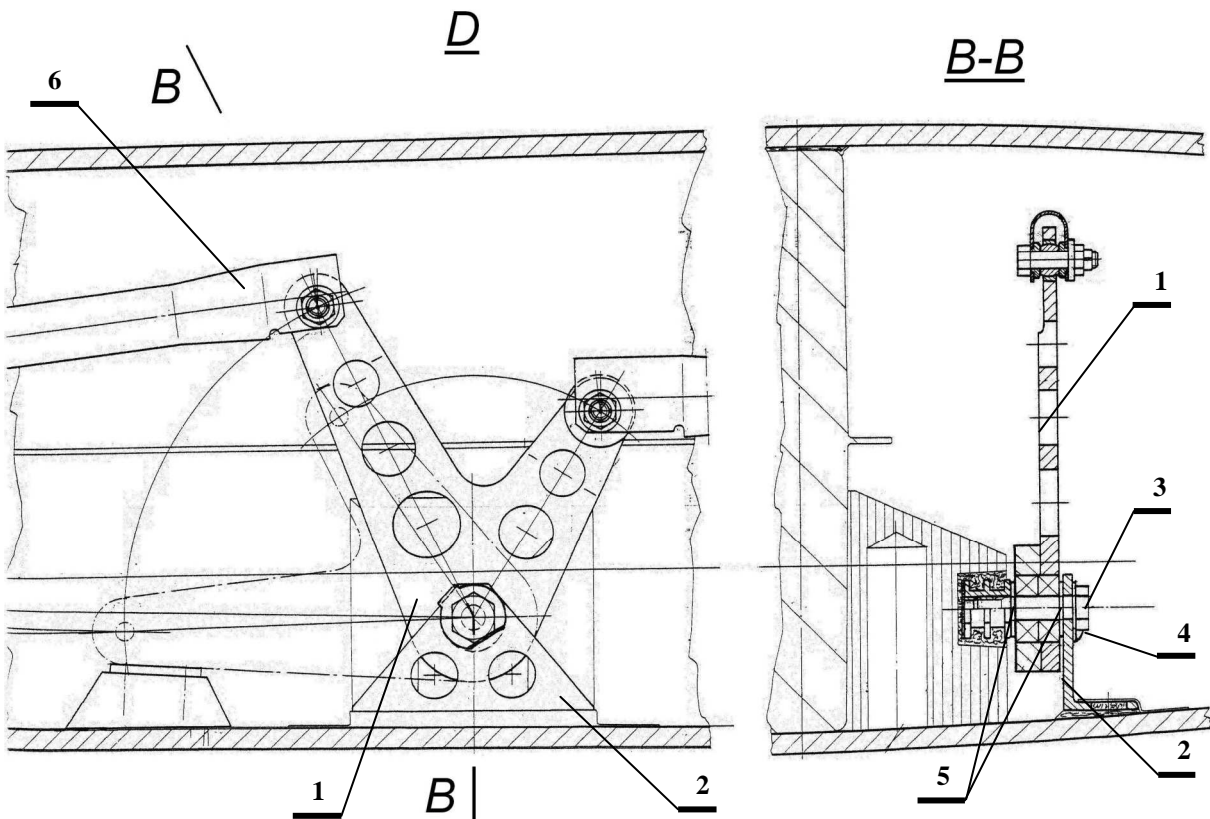
**Fig. 1. Bolt and washer replacing.**

The bolt's head, washer and lever's console are visible through hole of pushrod (6) in a wall of airbrake box. Following actions must be performed:

- 1- intermediate lever in airbrake control system
- 2- lever's console
- 3- M8x32 bolt
- 4- tab washer
- 5- 8,5x1 washer
- 6- pushrod

- 6.1. De-rig the wing.
- 6.2. Cut a hole in upper skin of the wing, according to Fig. 1.
- 6.3. Screw out and remove bolt M8x34, remove also spring-lock washer and spacer washers (5).
- 6.4. Screw in bolt M8x32 (3), with a tab washer (4) as a locking device, inserting also spacer washers (5) on their place.
- 6.5. Bend a tab of the tab washer (4) on the lever console (2) as shown in "D" view. Bend tab washer on the bolt (3) head, at arbitrary selected position.
- 6.6. After ensuring that assembling has been performed correctly, and bolt reliably locked by tab washer bent, repair the hole in wing skin according to Repair Manual of the glider.
