SERVICE BULLETIN

BE-062/SZD-50-3/2013 „PUCHACZ”

DATE: September 16, 2013
SUBJECT: Inspection of torque tube in air-brake control system
MODELS AFFECTED: All S/N of SZD-50-3 „Puchacz”
TIME OF COMPLIANCE: After receiving the SB

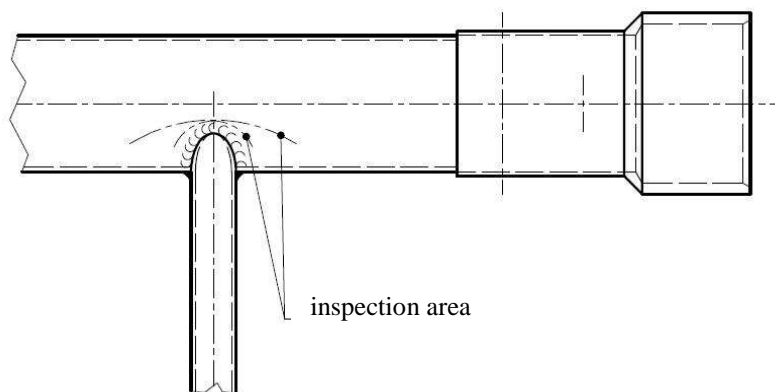
Up to 2003, during the flights, while operating the airbrakes, a few incidents of the torque-tube break-off from the lever located in fuselage, had been experienced. The damages occurred at the welded joint between the tube and the lever, which did not allow to retract the airbrake.

Possible reason could be a fatigue in the area of frequent occurrence of striking load, exceeding recurrently the established value or/and corrosion detected inside the area of opened tube.

- for the gliders still equipped with the old version of torque tube, with or without reinforced corner, do as follows (see Sketch 1):
 - annually or during „100-hrs” inspection, in case of whichever occurs first, inspect the welded joint of airbrake torque tube, acc. to the description specified in item 2(b) of this SB;

*Sketch 1 – Previous version of airbrake torque tube:
a) without reinforcement; b) with a single reinforcement*

1. Cracks, permanent distortion of torque tube as well as corrosion pit on tube's inner side in the area of welded joint are not acceptable. In case of one of the defects listed above – replace the tube with the new one, purchased from Allstar PZL Glider – item no. 503.64.30.00A. The old tube may be released into service if no one of described defects exists.
2. Slight, uniform corrosive deposit should be removed with fine abrasive sand paper (grid 600 at min). If no corrosive pits are present on the surface, prevent inner area of the tube with anticorrosive agent (for ex. Fluidol) and release the tube into service. However, replacement the tube with the new one could be recommended.

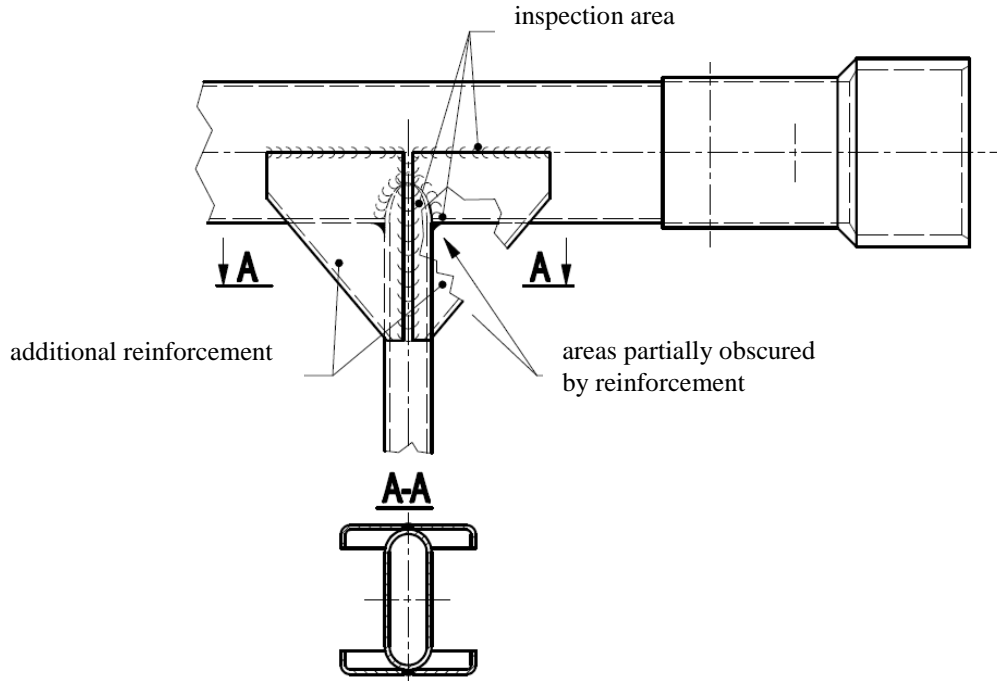
- for the gliders with the new type of torque tube with reinforced corners (see Sketch 2), i.e. the gliders from S/N 503.A.03.001 and up as well as others with the new type torque tube (see Sketch 2) do as follows:

- annually or during „100-hrs” inspection, whichever occurs first, check visually (disassembling of the tube from the fuselage is not necessary) the welded joint of the torque tube. Inspection of the areas partially obscured by the reinforcing plates is not required.

- during „1000-hrs” inspection check the welded joint of torque tube as described in 2(b) of this SB.

Sketch 2 – New version of reinforced torque tube
