**SERVICE BULLETIN**  
**BE-063/SZD-50-3/2014 „PUCHACZ”**  
Allstar PZL Glider considers compliance mandatory

**SUBJECT:** Inspection of rudder cable fitting blocks

**MODELS / SERIAL NUMBERS AFFECTED:** All SZD-50-3 „Puchacz”, SZD-50-1M (X-127) and SZD-50-2 (X-129)

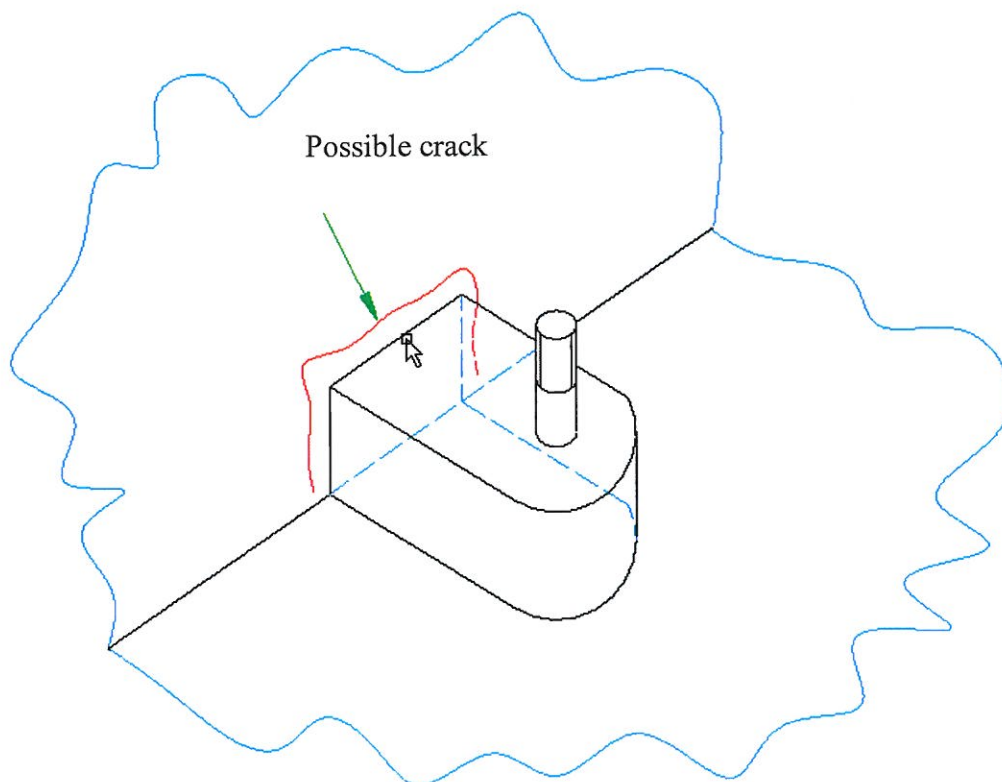
**Figure 1. Crack location**

Allstar has received the fields report as during the flight, while retracting from the spin, after applying of front left rudder pedal, the fitting block of the rudder cable to the floor went out.

The reason could be improper gluing of the block including the fitting screw to the fuselage shell or partial cracking of gluing of fuselage's shell to the stiff block.

Immediately after receiving of this SB inspect the painting area around the block, in the place of fitting of the rudder cables and gluing to the fuselage's shell, close to the pedals: left and right (see Fig. 1). If found the crack, this is the sign of separating process of the block from fuselage's shell.

In case of crack's found in any places (left or right fitting), before the next flight, correct the fitting of both blocks to the shell. Follow acc. to the description in item 3.2 of the SB.  
In cracks do not appear, the glider may be exploited until the repair acc. to item 3.2 is to be performed.
