**SERVICE BULLETIN**  
**No BE-011/SZD-59/2009 „ACRO”**

**DESIGNATION-TYPE/MODEL:** SZD-59 „ACRO”

**CONCERNS:** Replacing of a fuselage frame part.

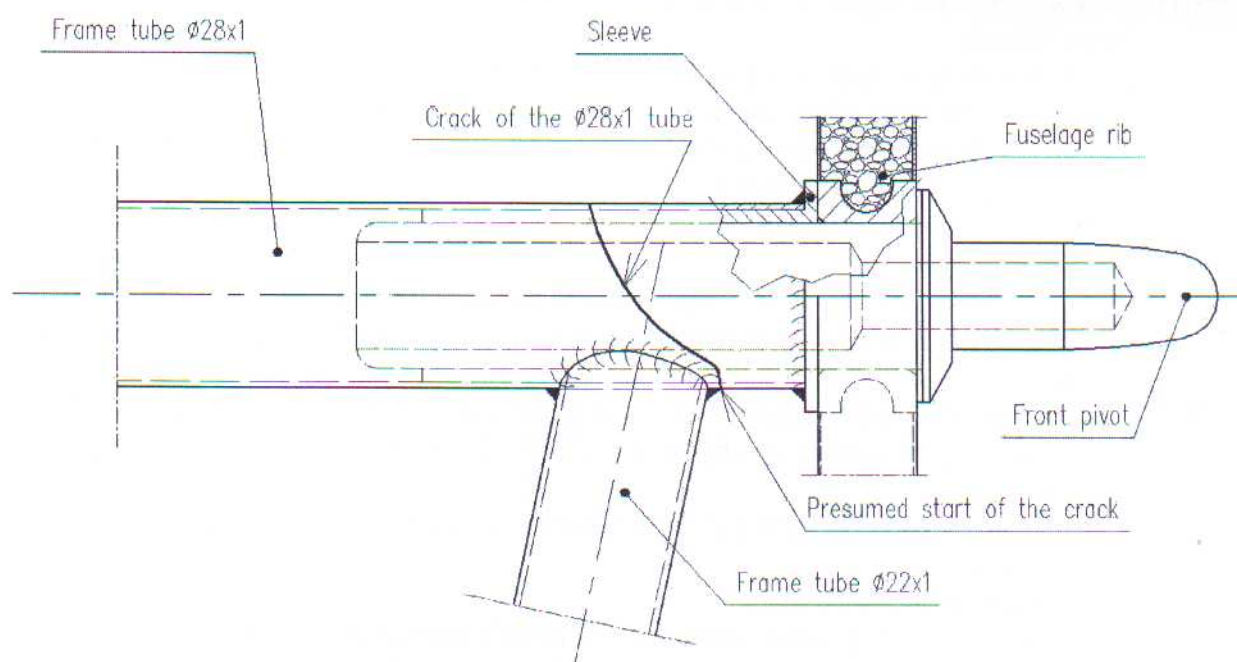
Fig.1.

During the exploitation of gliders a fatigue crack of the left front welded joint of the fuselage frame had been detected. The crack is a result of presumed high stress level and intensive exploitation in aerobatics. Real stresses initiates the cracks which can, in extreme case, cover all the diameter of the outer tube (Fig.1.).

Front wing fixing point
