Airworthiness Directive

AD No.: 2018-0081

SZD-55-1 sailplanes

ATA 27 – Flight Controls – Elevator Control System / Vertical Tail – Inspection

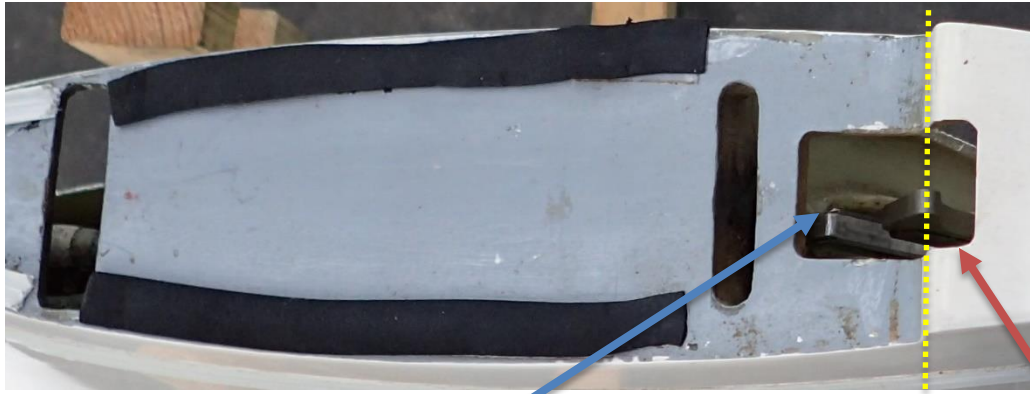
Drawing 2

Slot for the elevator lever

Slot extension not as designed

- (1) Within 60 days, or during the next annual inspection, whichever occurs first after the effective date of this AD, visually inspect the size of the opening on top of the vertical tail (see Drawing 2, Appendix 1 of this AD).

- (2) If, during the inspection as required by paragraph (1) of this AD, discrepancies are detected, before next flight, contact Allstar PZL Glider for approved repair instructions and accomplish those instructions accordingly.
